Drive Shaft Failures In Automobile

A.Vinay Gananatha Durga Sai¹ | T.vamsi¹ | K.Durga Deepak¹ | K.Pavan Venkat¹

¹Department Of Automobile Engineering , Godavari Institute Of Engineering And Technology(A) , Rajahmundry, A.P.

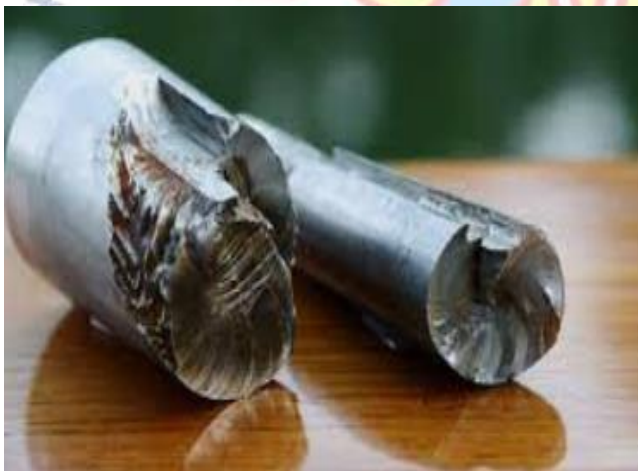
Drive shaft failure while it is still operating

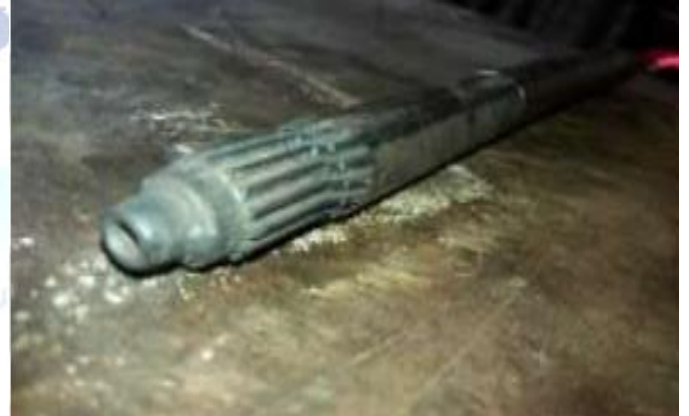
- The 320mm long, 20mm diameter drive shaft shears free from the splines.
- Perform a shaft failure analysis
- Track down the answer.

Drive shaft used in FSAE Car

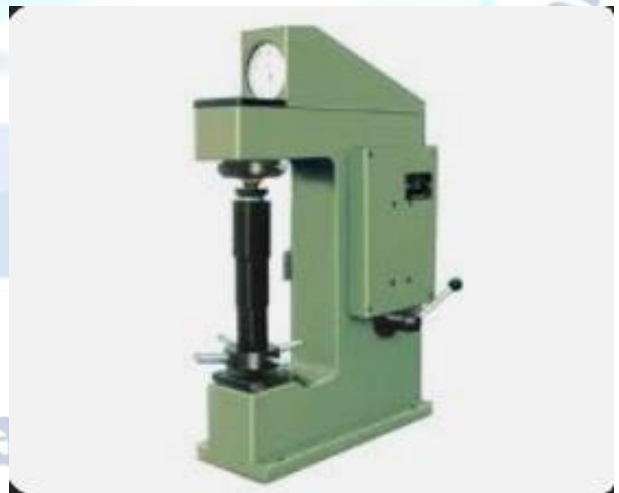
Upon further investigation, it was discovered that the drive shaft's hardness had decreased as a result of normalization. It has been lowered to 17 HRC. It can be discovered by using a Rockwell hardness test machine to determine its hardness.

Rockwell hardness testing machine

The drive shaft failed for the main reason that the EN24 material's actual hardness, which was 26 HRC, had declined to 17 HRC due to improper heat treatment.

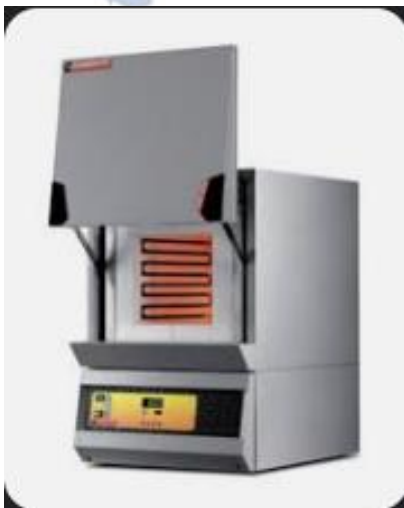
The heat treatment given to the defective component is called a hardening heat treatment. In this, the component is heated to its 880 C austenizing temperature and maintained there for 30 minutes before being quickly cooled in a water bath. This is essential for the formation of martensite. 55 HRC is the current hardness. This hardness is lessened by tempering at high temperatures.

Muffle furnace

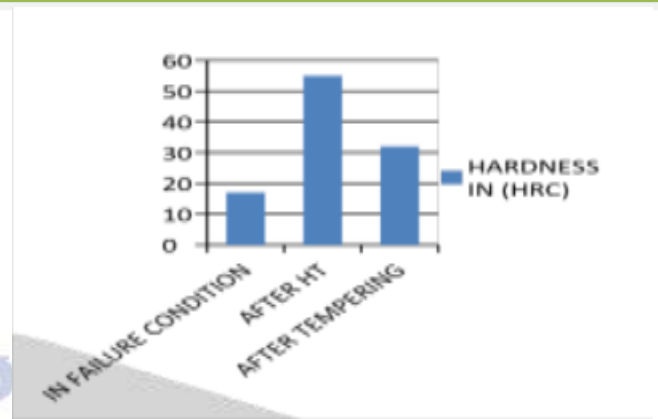
Heat treatment changes the hardness

It was decided to give the drive shaft a hardening heat treatment because the drive shaft's initial hardness (in a failure condition) was 17 HRC, which is too low. This results in a roughened surface of 55 HRC, which is too high because the hardening is also making the material more brittle. And following tempering, the hardness is reduced to 32 HRC, which is what the drive shaft needs.

In the first 90 laps on the track we designed, the propeller shaft with a 17 HRC failure occurred. This exhibits a very poor result. The drive shaft was then placed in a safe zone with 35 HRC at the surface and given the previously mentioned heat treatment (hardening followed by tempering). This drive shaft then completed approximately 320 laps on the same track.
